# CASE STUDY

Executed a 176.23-mile high-flow natural gas run using speed-controlled cleaning and debris mapping tools, delivering pre-ILI data within a 12-hour reporting window.

MAY 2025

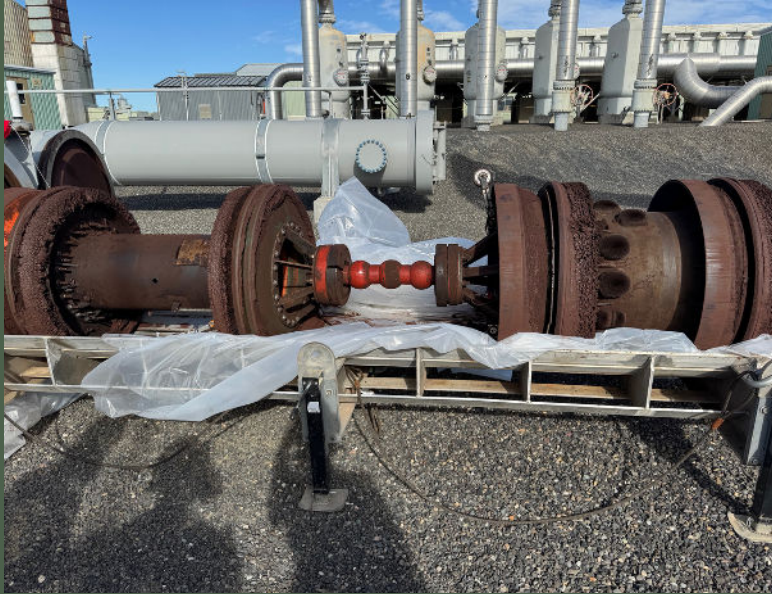
IMAGE 1 - SCP AND DEBRIS MAPPING TOOLS POST RUN

Three technicians were deployed for the run, including personnel from Inline's Speed Control and Debris Mapping divisions. The tool was configured with cleaning elements—sealing cups, scraper discs, brushes, and magnets—to support light cleaning while enabling controlled movement. The SCP was attached to the Winterhawk Debris Measurement and Mapping tool using a pig link, allowing for accurate debris data collection under high-flow conditions.

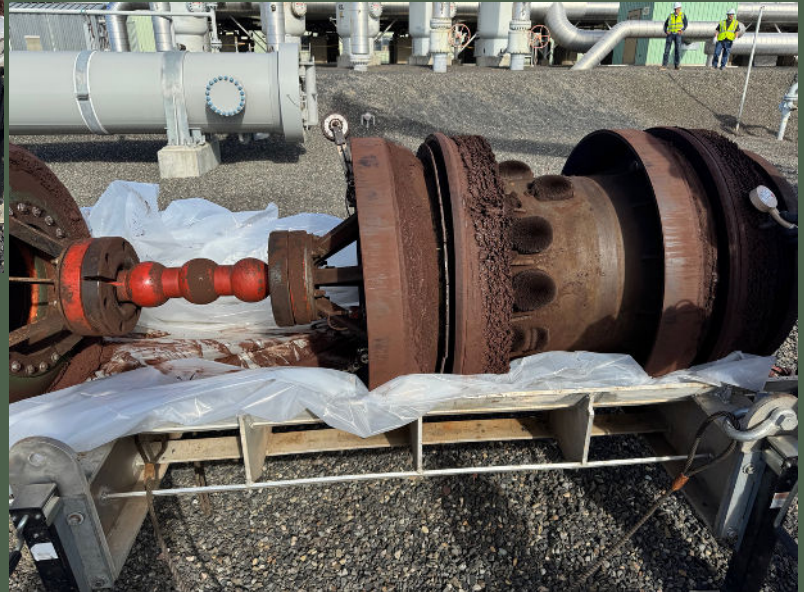
IMAGE 2 - SPEED CONTROL PIG AND PIG LINK

A pig link was used to connect the SCP to the Winterhawk tool, enabling the Winterhawk system to travel at a reduced, controlled speed for accurate debris data collection. Software support and IT resources were on standby throughout the operation to ensure seamless data transfer and processing. Inline's analysts were prepared in advance and delivered the report within 12 hours of tool retrieval. This controlled, data-driven approach ensured the pipeline was safely and thoroughly cleaned, while also providing the detailed insight necessary to support a successful ILI run under strict time constraints.

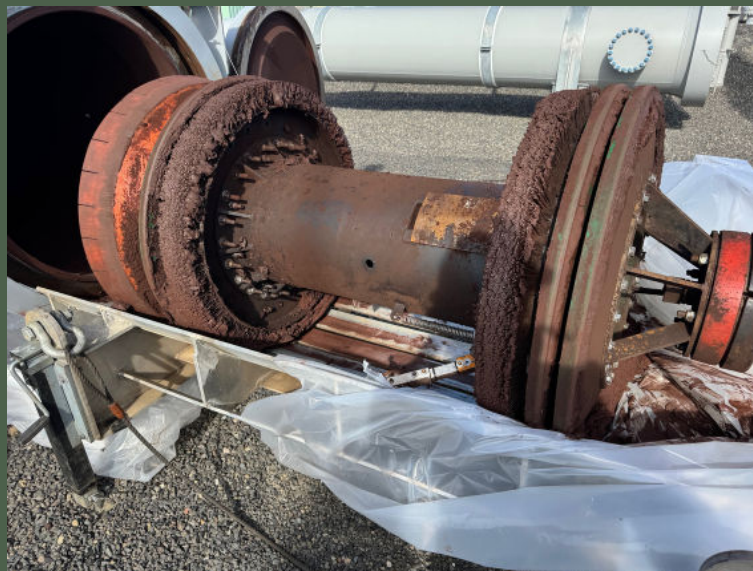
IMAGE 3 - DEBRIS MAPPING TOOL
